Citizen Volunteer Water Quality Monitoring on Alabama's Coast

Dog River

Alabama Water Watch
August 2004

Introduction to the Alabama Water Watch Coastal Series

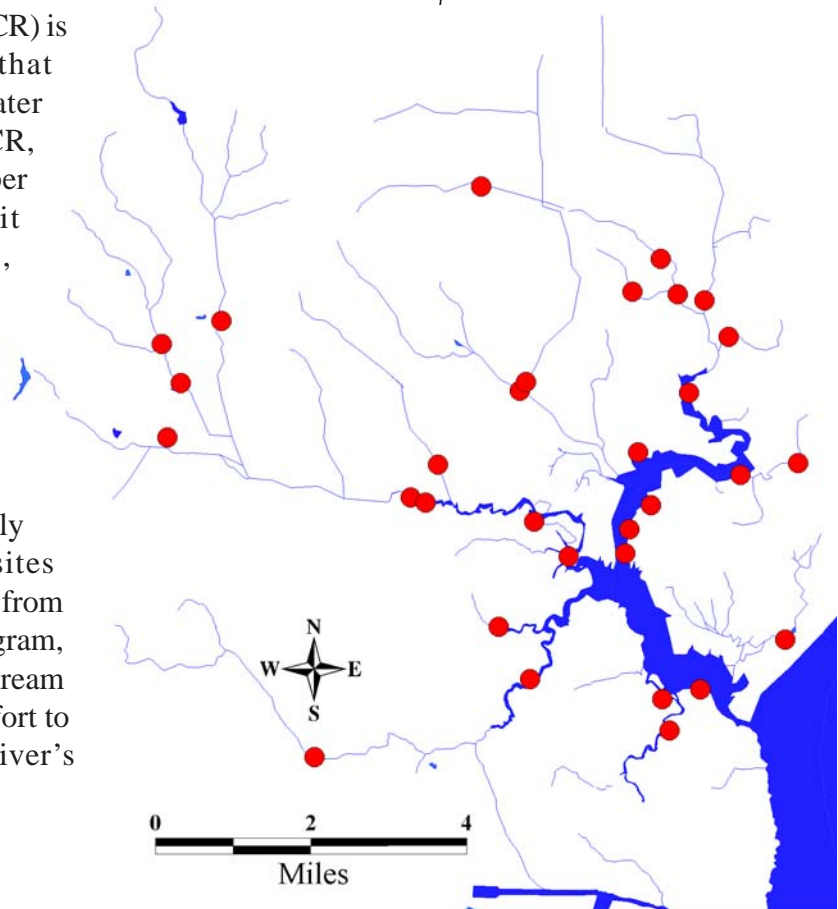
Dog River Clearwater Revival sampling sites (●)

- DRCR volunteers have strategically located water quality monitoring sites throughout the watershed. With support from the Mobile Bay National Estuary Program, DRCR purchased signs to label major stream crossings within the watershed in an effort to improve public awareness of Dog River's tributaries.

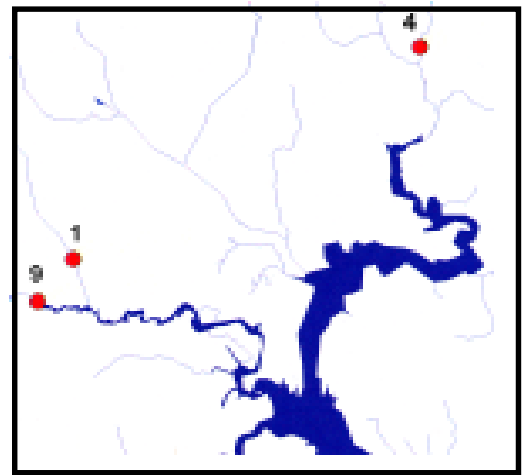
DRCR sites 1, 4 and 9 in the Dog River watershed

- The graphs on pages 6-8 document both seasonal and multi-year changes in water quality at three DRCR sampling sites (see map on p. 7). Each data point on a graph represents the average of one to several measurements per month.

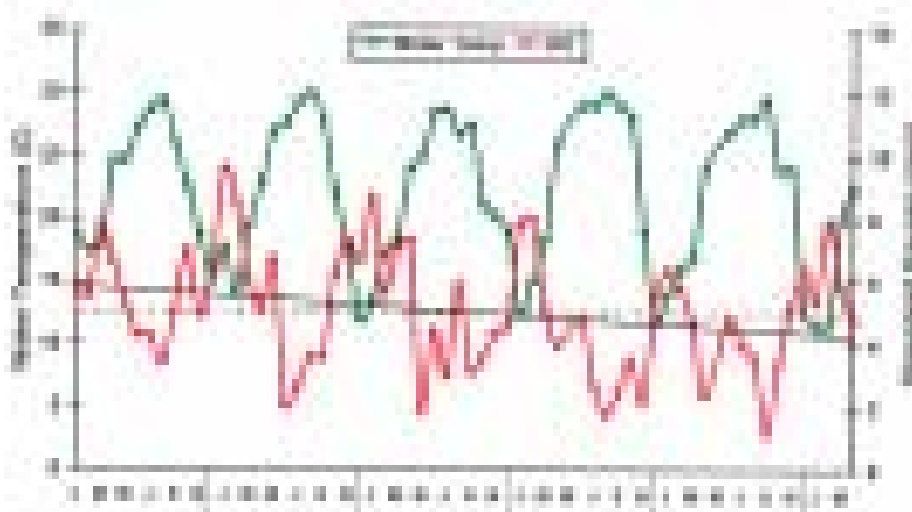
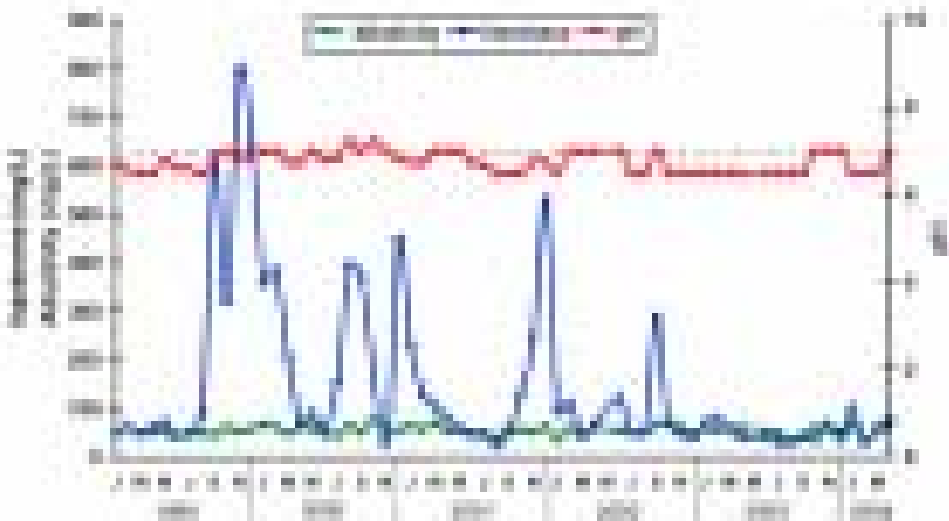
Site 4 (06005004) - Mimi Fearn
Eslava Creek at McVay Road

- The water quality of Eslava Creek (Site 4) was quite different from that of Halls Mill Creek. Eslava Creek had higher water temperatures (14-30 C or 57-86 F).

- DO levels (black trend line) in Eslava Creek had the opposite trend of Halls Mill Creek and have steadily declined to values that are detrimental to fish and other aquatic life.

- The pH of Eslava Creek was similar to Halls Mill Creek, mildly acidic. Alkalinity was also generally similar, but hardness values at Site 4 had abrupt peaks with monthly averages that reached 400-800 mg/L. The highest single-date value for hardness at site 4 was about 2,000 mg/L on September 26, 1999! The hardness peaks occurred during dry periods (especially during the drought years of 1999-2001) and were caused by brackish water intrusion (high in calcium and magnesium) from the bay. Alkalinity remained low while hardness peaked because brackish water is not high in carbonates and bicarbonates.

- Because the stream is of a lower quality than its use classification (Fish and Wildlife), it is a candidate for an ADEM and EPA registry of impaired streams called the 303(d) List. Low DOs and higher temperatures are probably because the subwatershed is more urbanized, the headwaters have been diverted, and the stream is often stagnant.

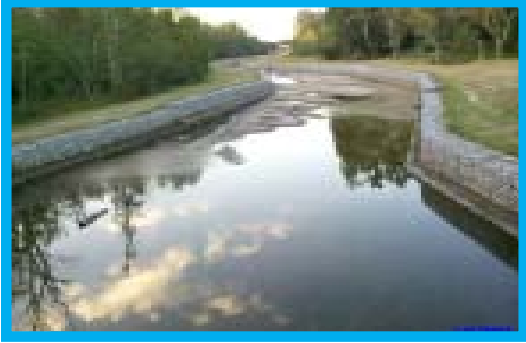
A channelized section of Spring Creek with streamside vegetation removed

- The water temperature of Spring Creek (Site 1) over the last five years seems to have an increasing annual range (higher in summer, lower in winter). This is probably because the streamside vegetation has been removed, exposing the stream to more sunlight and a wider range of air temperatures. The site also has had greater seasonal fluctuations in DO (black trend line) over time that may be related to changes in the streamside cover or flow. However, the DO has remained equal to or above 5 ppm.

Spring Creek, when natural, riparian vegetation was replaced with extensive limestone riprap. Limestone is calcium carbonate, which increases both alkalinity and hardness of water when it dissolves.

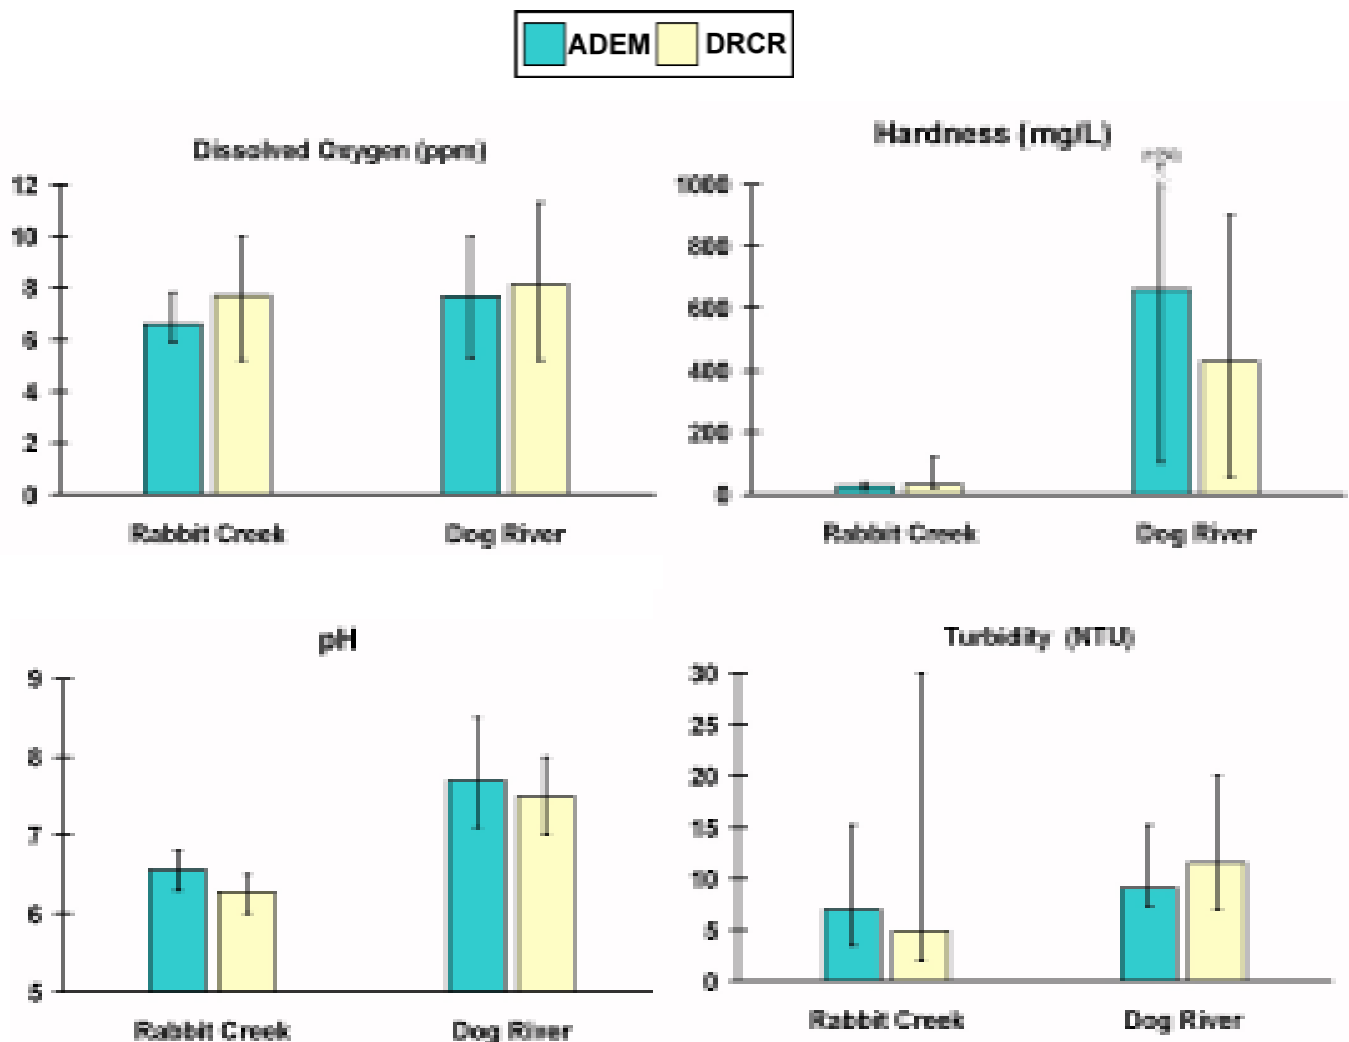
DRCR Sites 17 (06005017) and 8 (06005008) with ADEM sites RBTM-3 and DGRM-2 (ADEM 2003). Bars represent the average value of a parameter. Lines within bars represent the range of values.

- By comparing DRCR water chemistry data to professional data collected at about the same time and place, the credibility of the citizen data can be evaluated. In the graphs above, 41 records of DRCR from 1999-2003 were compared to 12 data records of the Alabama Department of Environmental Management (ADEM) from 2001.

- The two data sets were generally comparable and revealed water quality differences between Dog River and Rabbit Creek. Average dissolved oxygen, hardness, pH and turbidity were all higher in Dog River than in Rabbit Creek, as documented by both DRCR and ADEM. DRCR had more than 3-times the data records to substantiate these conditions, and they also are the only group collecting data from several other sites in the watershed.

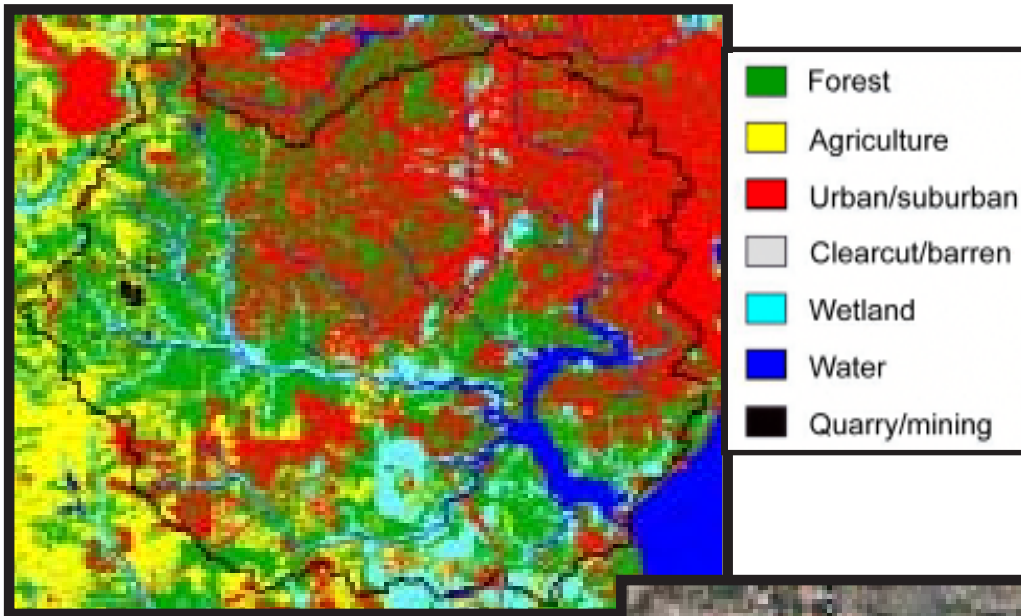
A land use map generated from 1992 Landsat satellite imagery of the Dog River watershed (delineated with black line)

- A comparison of these two watershed images indicates significant land use changes over a 10-year period. The 2002 image (right) shows evidence of increasing urbanization in the western and southern portions of the Dog River watershed.

- Relatively open, forested areas have decreased and developed plots have increased in the upper Halls Mill Creek and Rabbit Creek watersheds. Such development tends to decrease water infiltration and increase runoff that transports sediment, nutrients, pathogens and other pollutants to tributaries of Dog River.

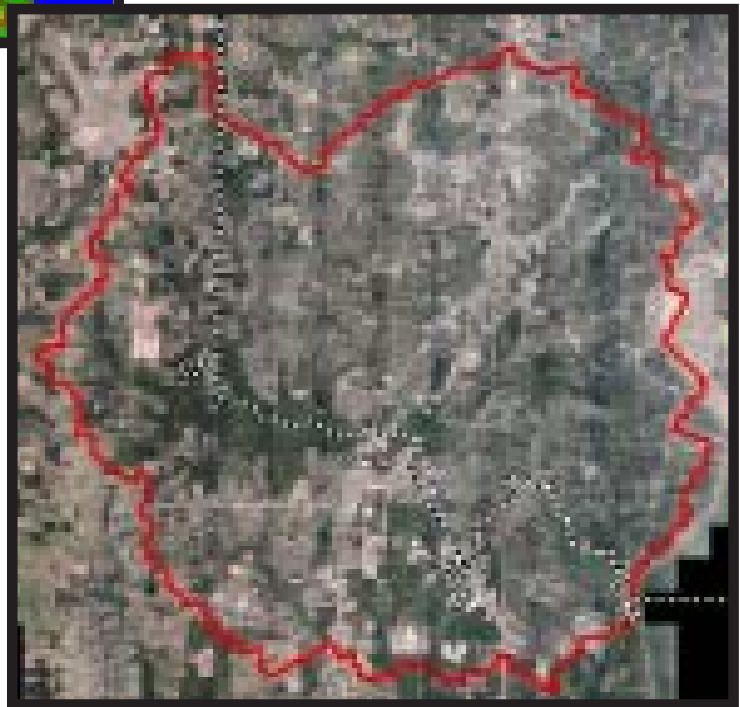
An aerial photograph taken in March 2002 of the Dog River watershed (delineated with red line) and Mobile City limits (delineated with dashed line). The City of Mobile GIS Department used color orthophotos to create this image.

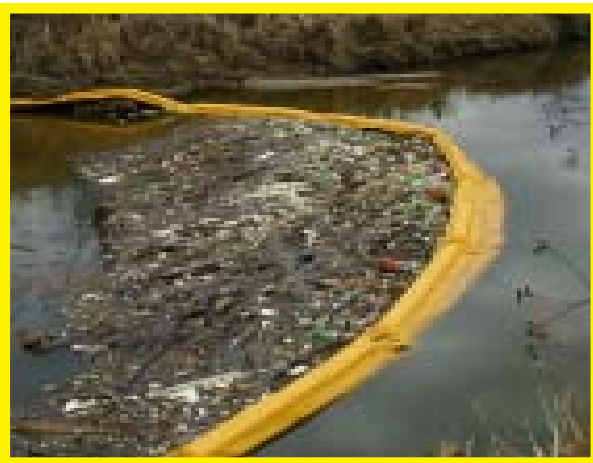
A sediment curtain on Moore Creek catches more litter than silt

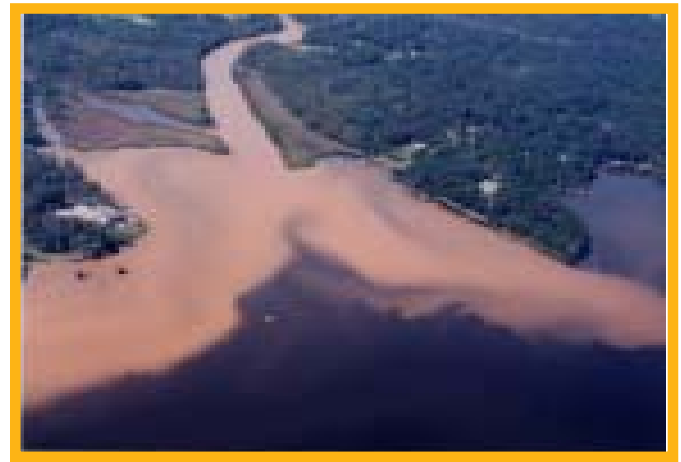
Aerial photograph, taken by Gerritt Carver in 1998, showing a sediment plume entering Dog River after heavy rainfall associated with Hurricane Georges.

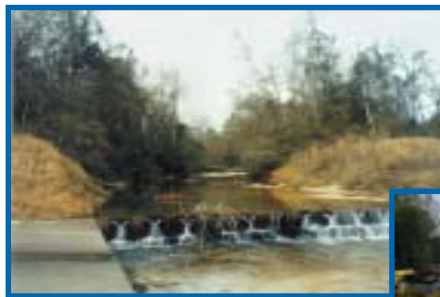
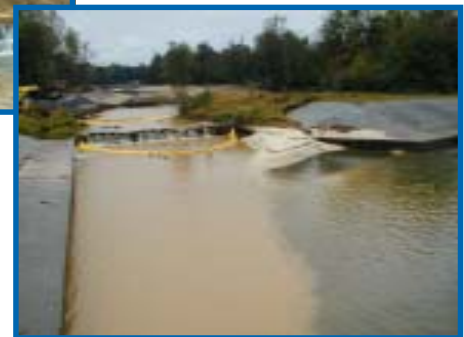
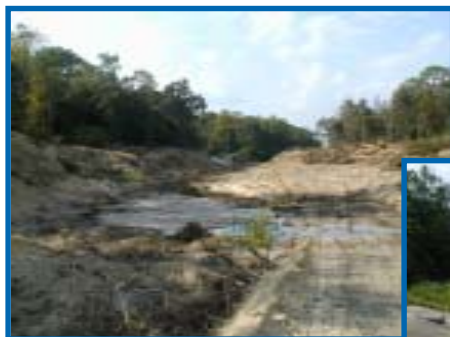
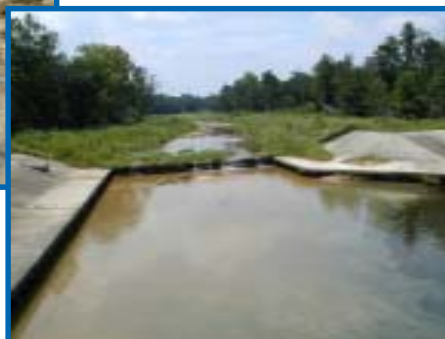
- This series of photos is of Moore Creek, an urban stream that has undergone extensive alterations.
- The City of Mobile has straightened and armored much of the channel to more efficiently convey stormwater runoff and prevent flooding and erosion.

- These changes protect homes and infrastructure from water damage, but essentially destroy much of the natural stream habitat and its aquatic life.
